## **APPENDIXES**

This Appendix contains prints of digital images depicting natural and cultural aspects of the project area on Kelleys Island, Ohio. The Appendix is subdivided into 4 sections which comprise the following topics:

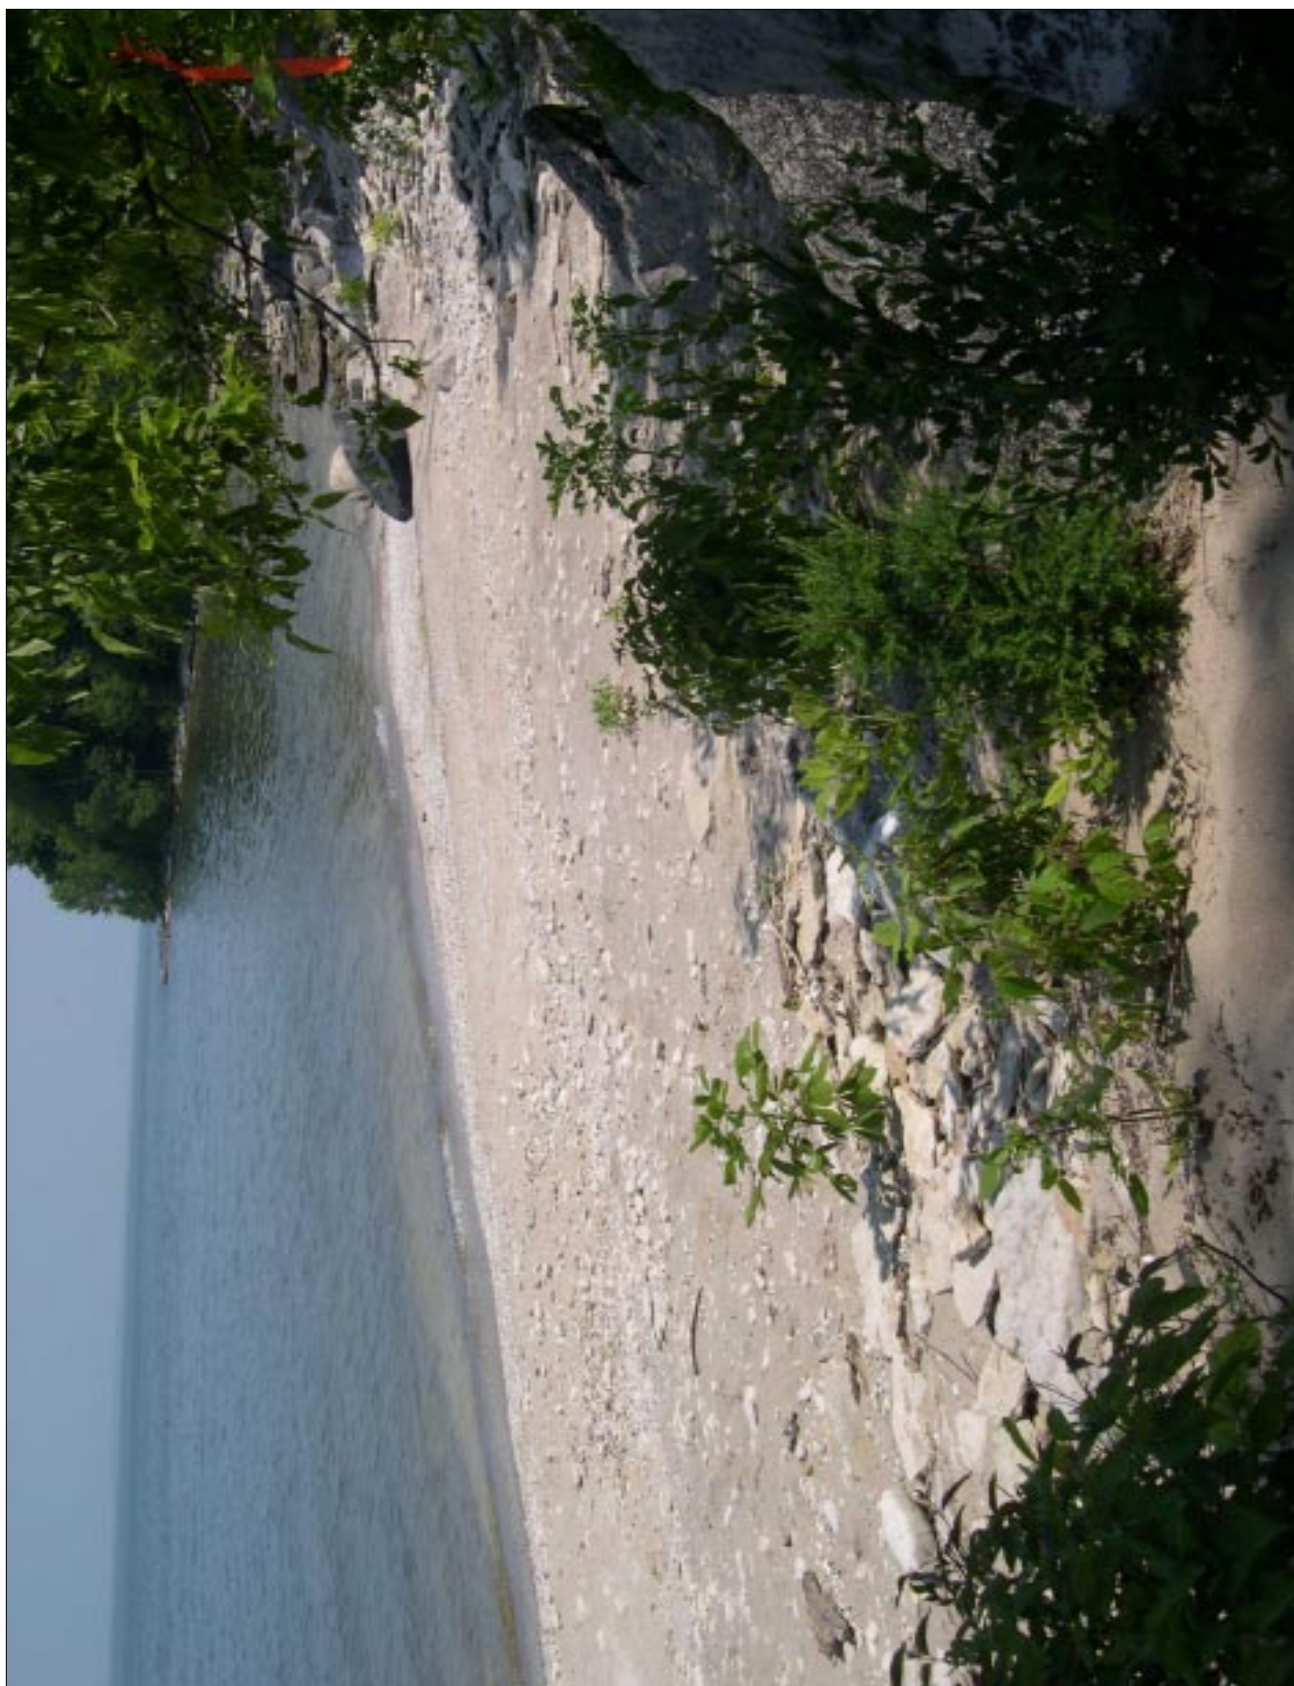
*Image SH-9. Shoreline view to the north from transect L; note sandy beach with limestone cobbles at center of embayment (June 8, 2004).*

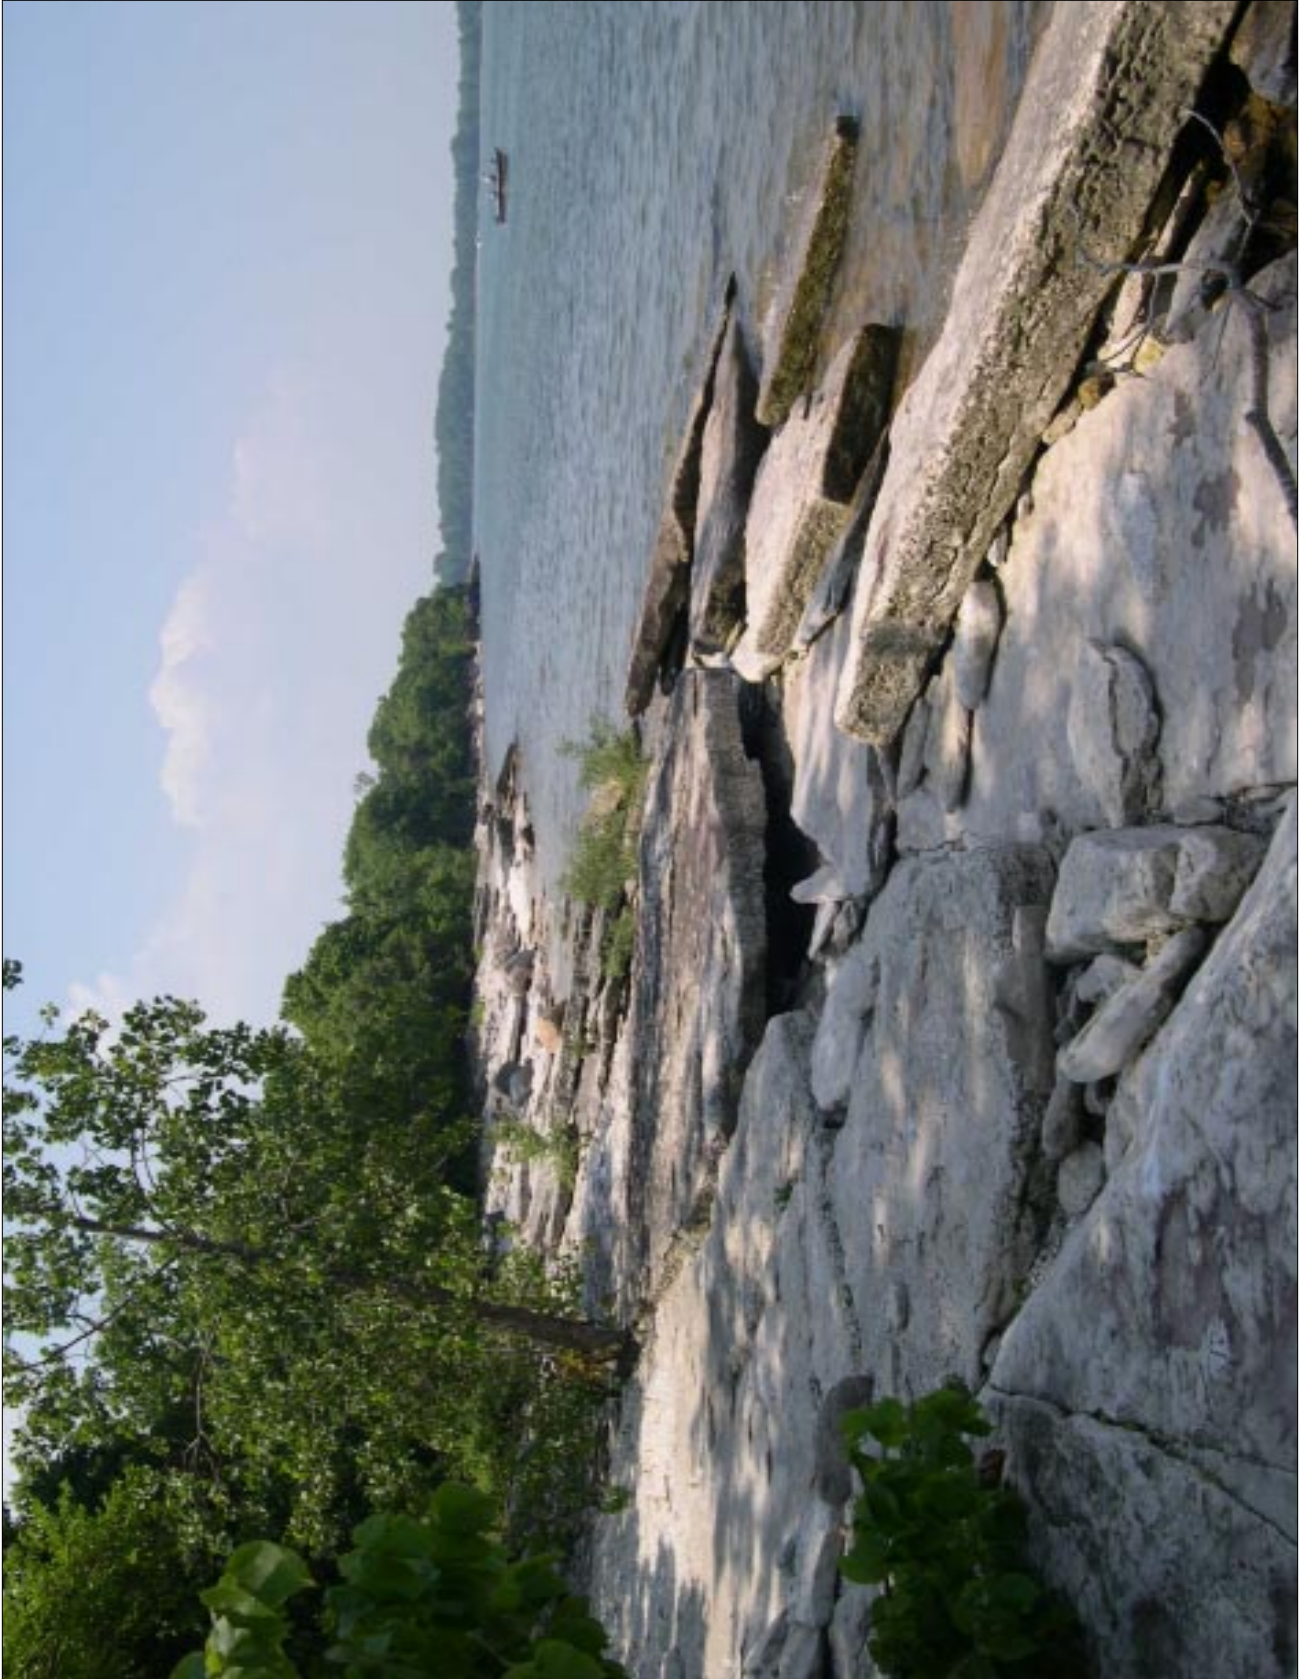
*Image SH-10. Shoreline view to the southwest from transect K; note large limestone slabs dislodged from the bedrock ledge (June 8, 2004).*

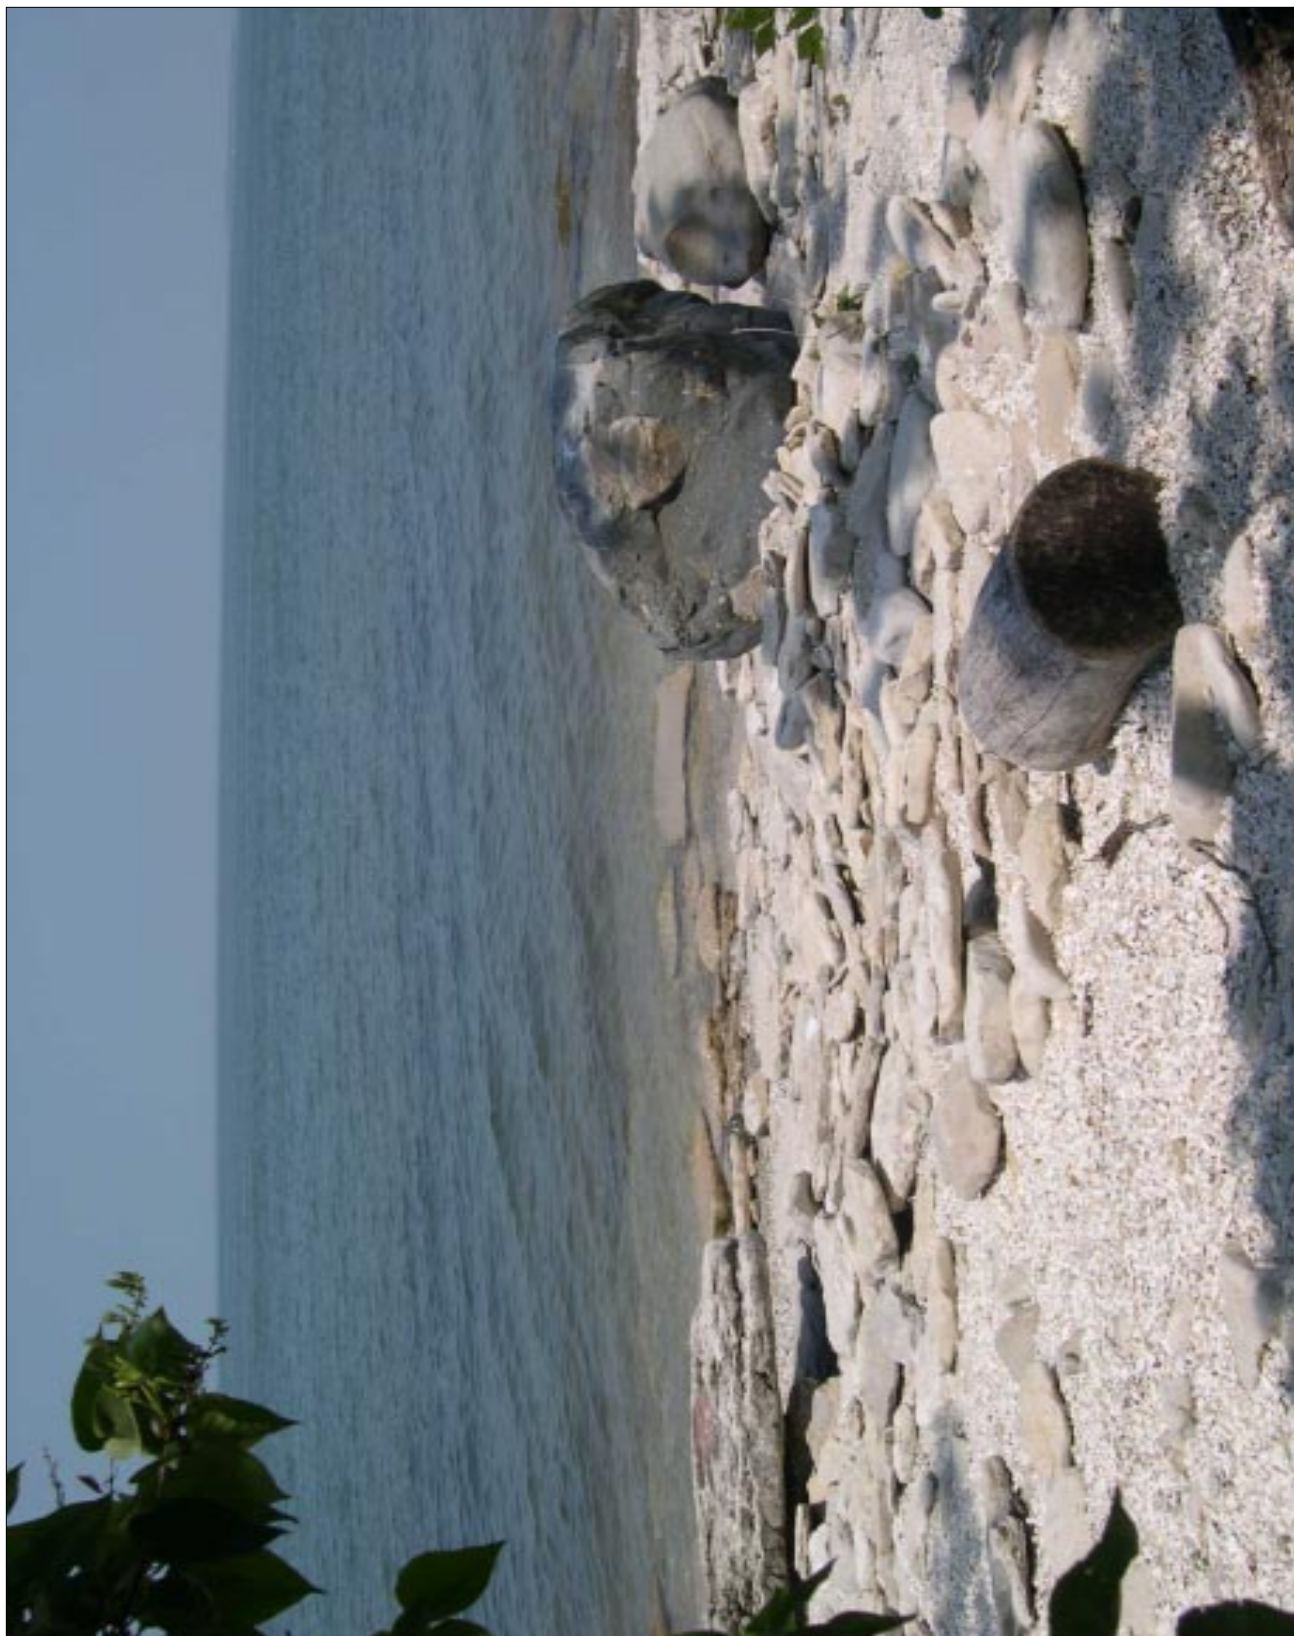
*Image SH-11. Shoreline view to the northwest along transect H (near center of proposed boat docking facility); note mixed materials of the beach ranging from sand and granules (largely zebra mussel shells and fragments) to limestone slabs and glacial boulders (June 8, 2004).*

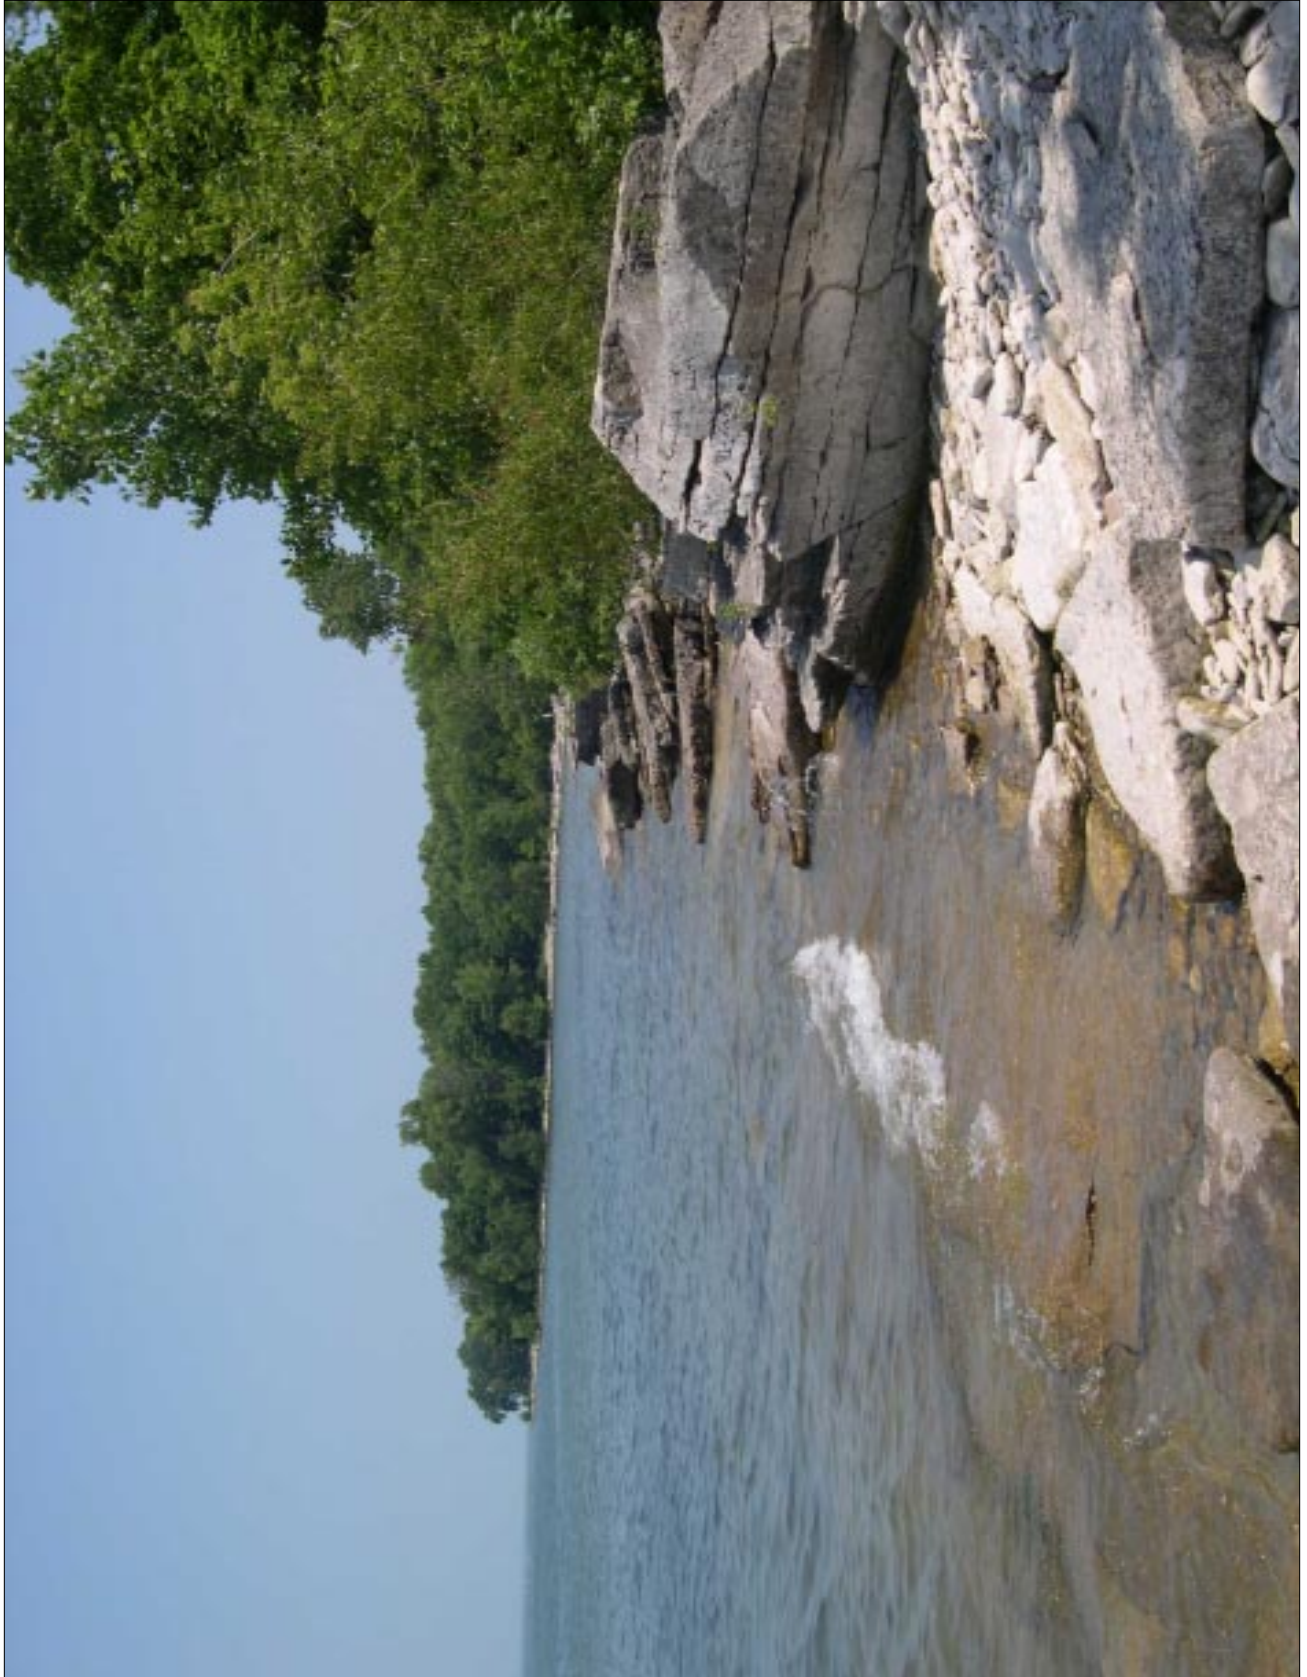
*Image SH-12. Shoreline view to the northeast from transect C; note massive limestone ledge at waterline and bedrock shelf offshore (June 8, 2004).*

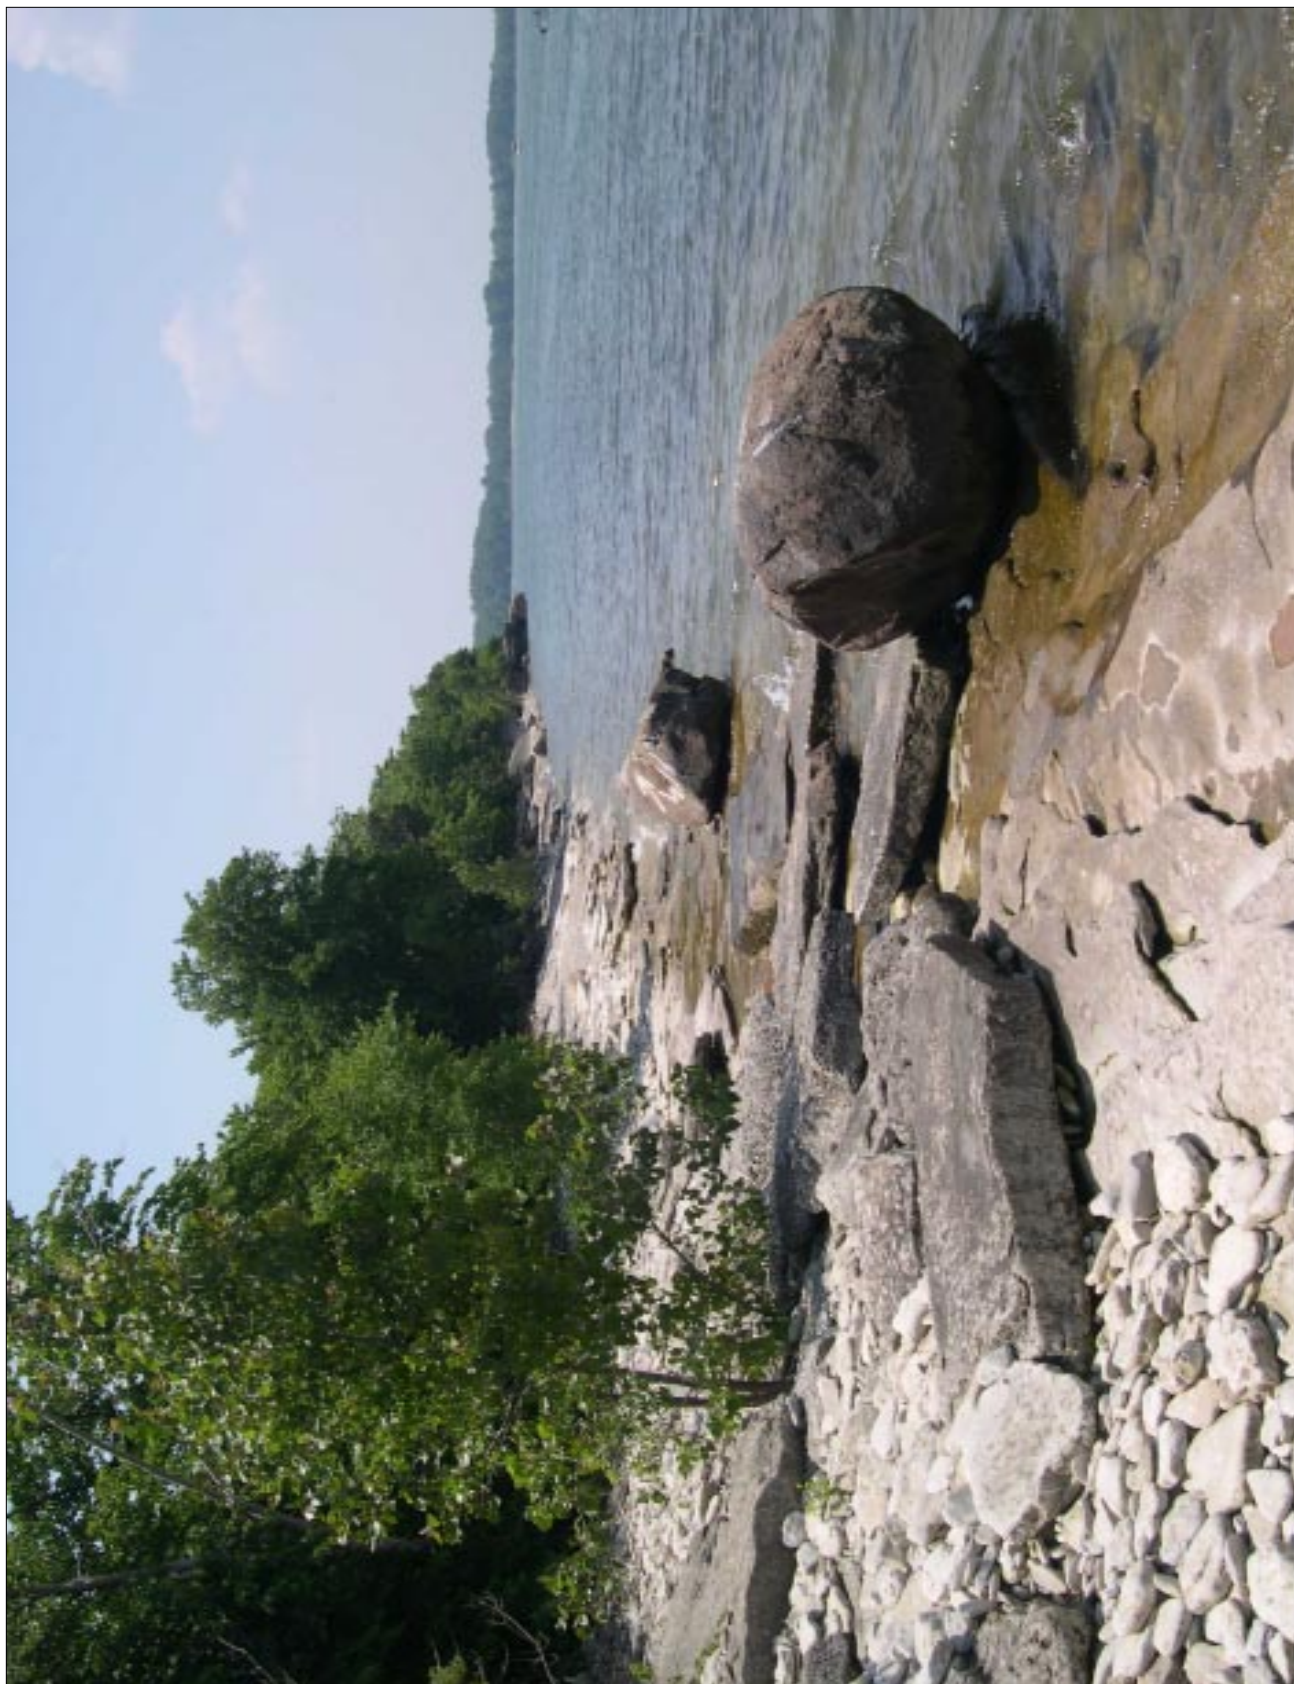
*Image SH-13. Shoreline view to the southwest from transect C, in the vicinity of the shipwreck of the scow schooner W. R. HANNA; note large glacial boulders at waterline (June 8, 2004).*

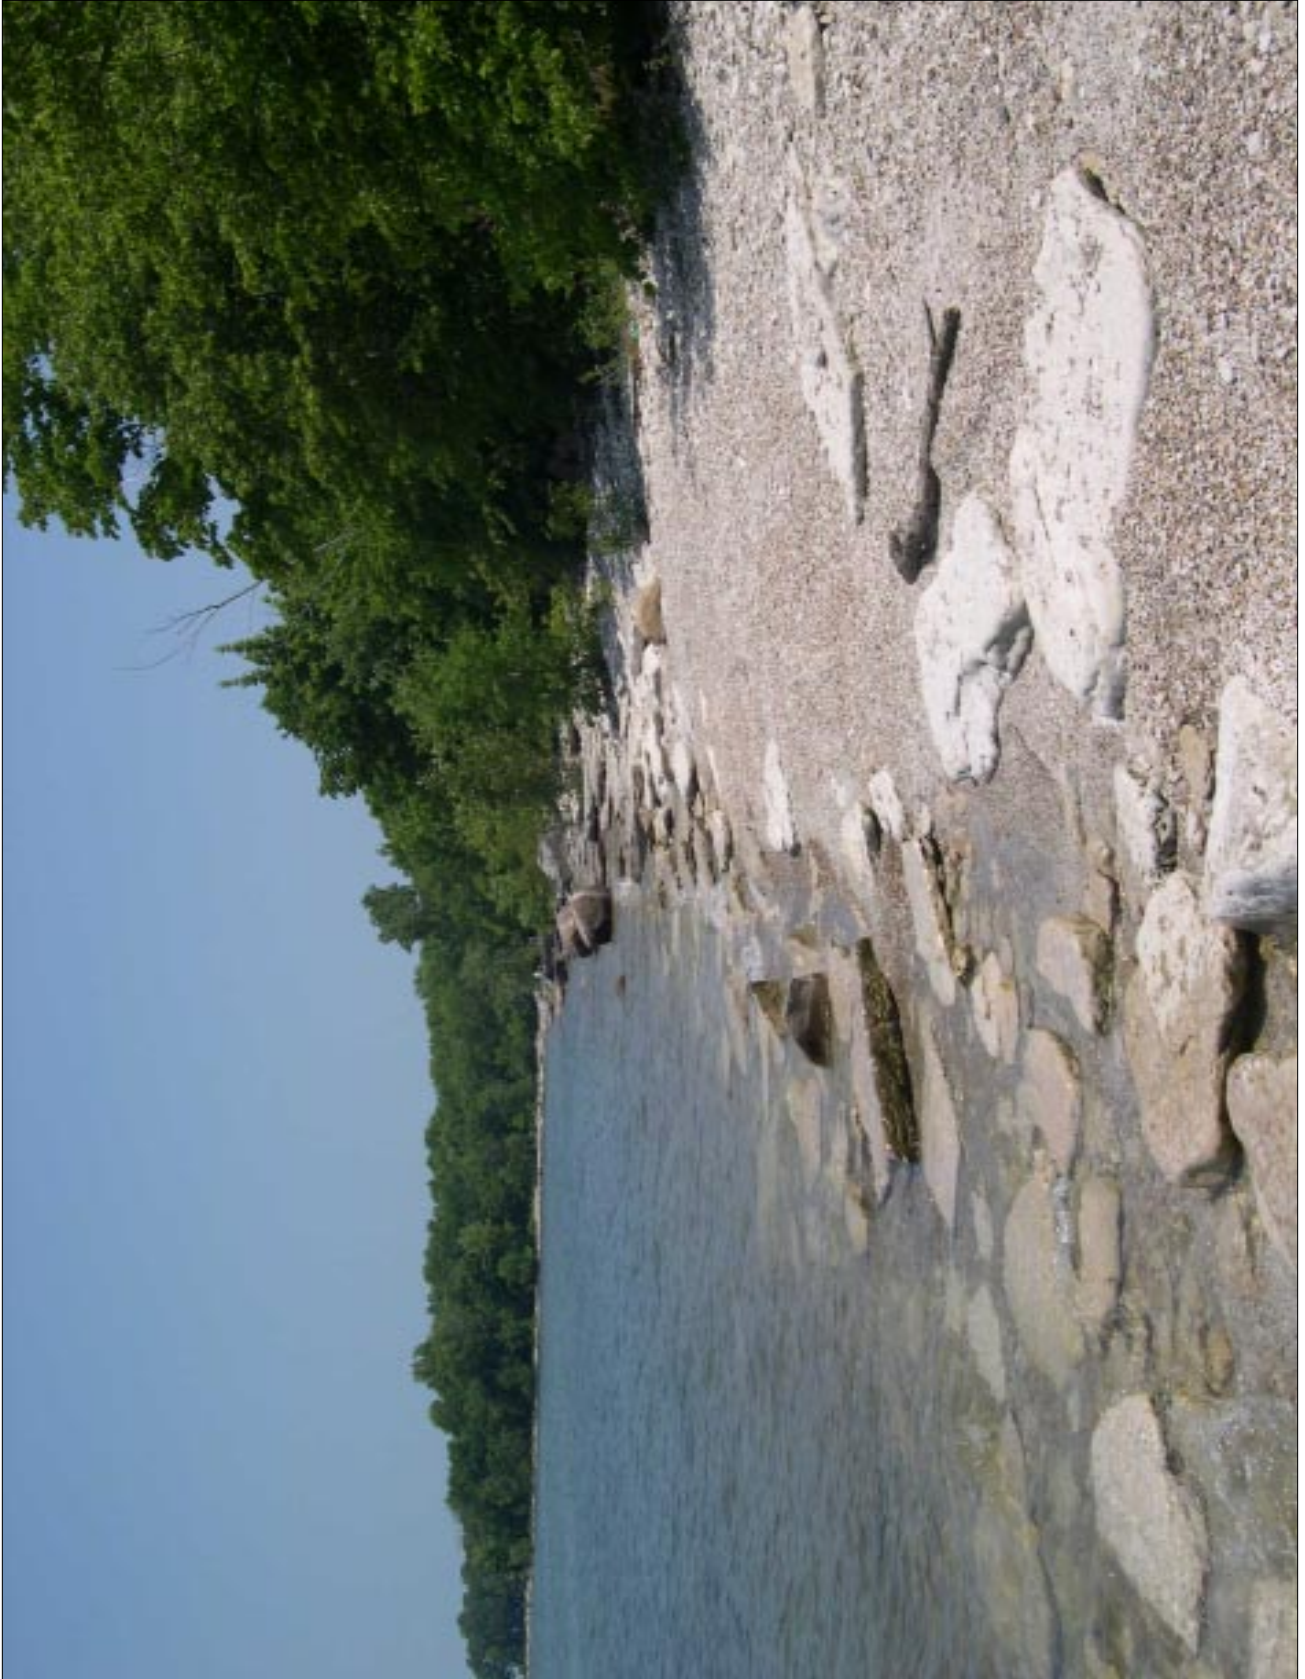
*Image SH-14. Shoreline view to the northeast from transect A; note the broad embayment along the Predevelopment, Ltd. tract (June 8, 2004).*

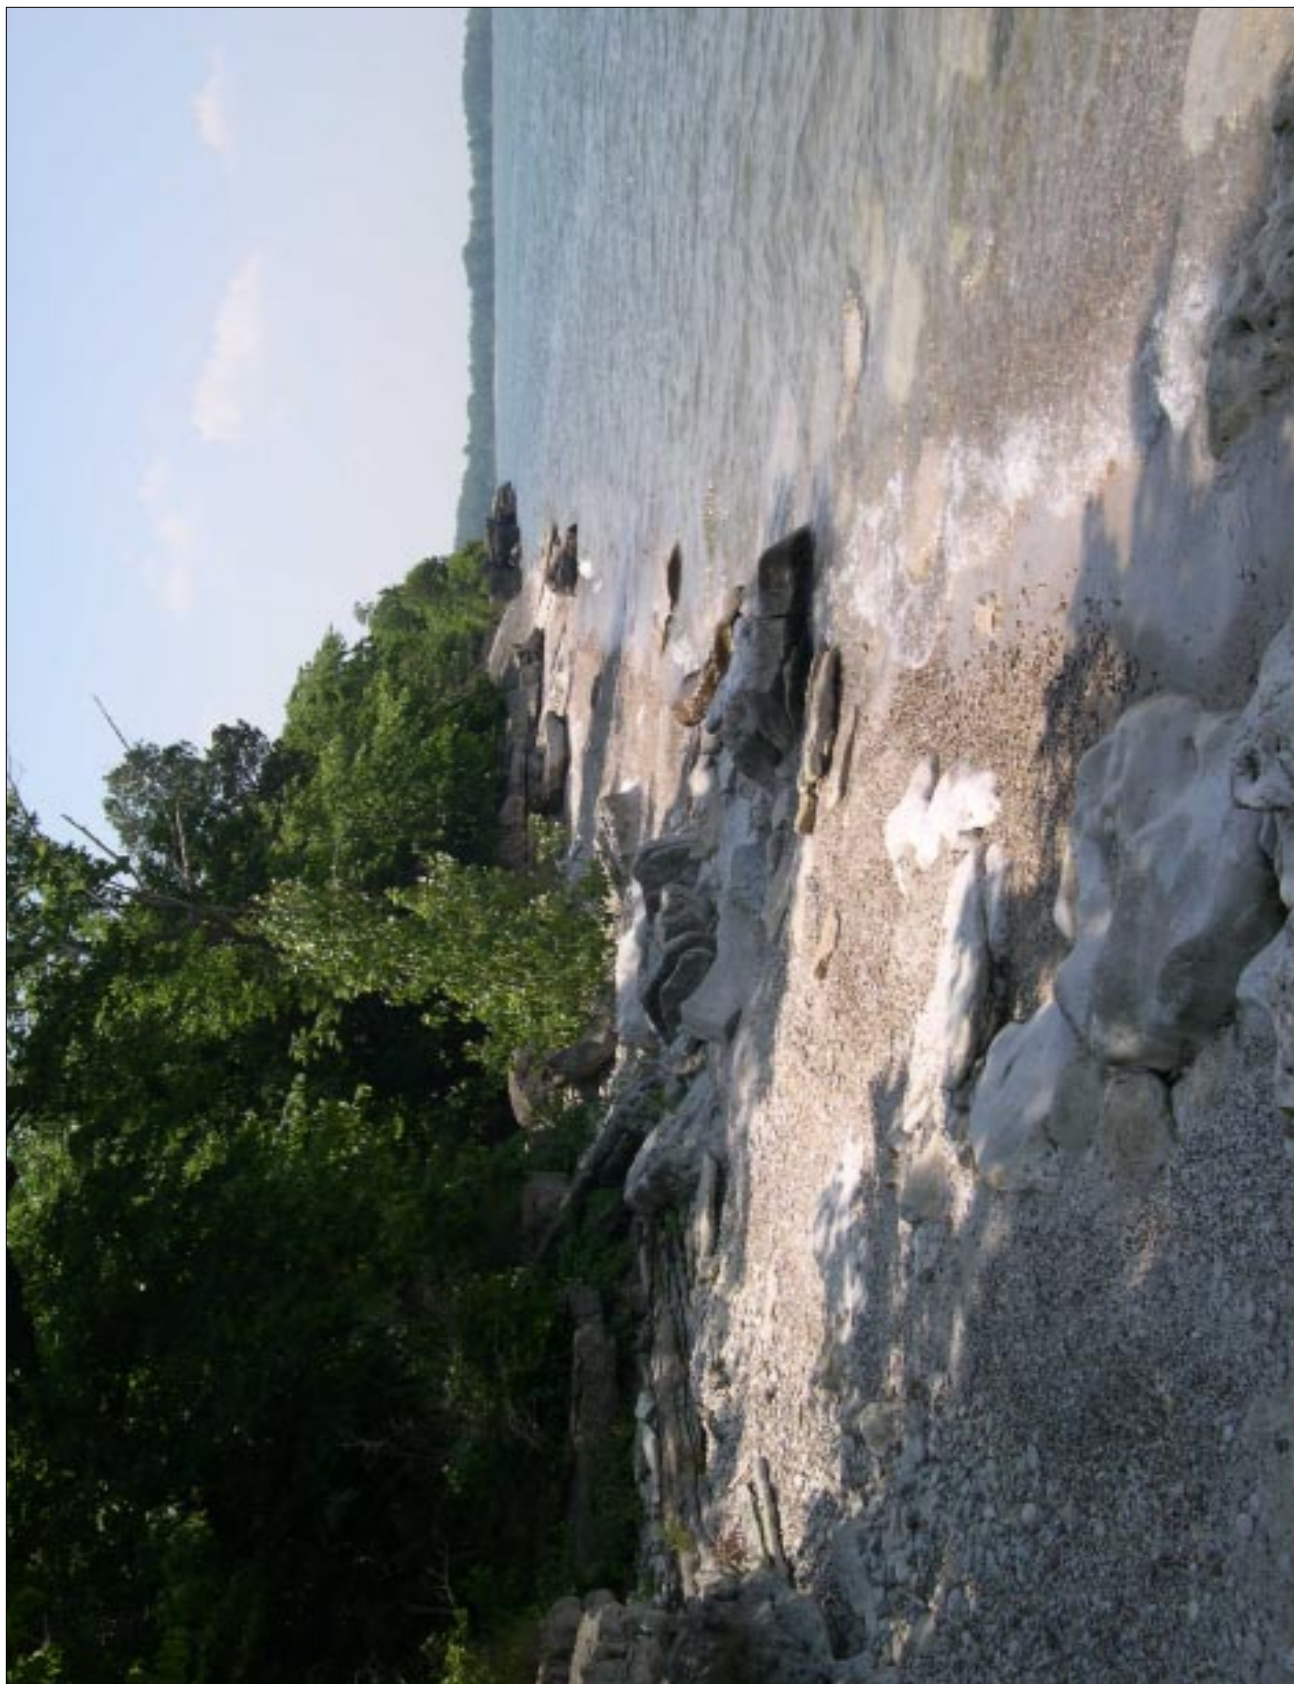
*Image SH-15. Shoreline view to the southwest from transect A; note the sand and granule beach mixed with limestone slabs that grades to a cobble beach and bedrock at the backshore (June 8, 2004).*

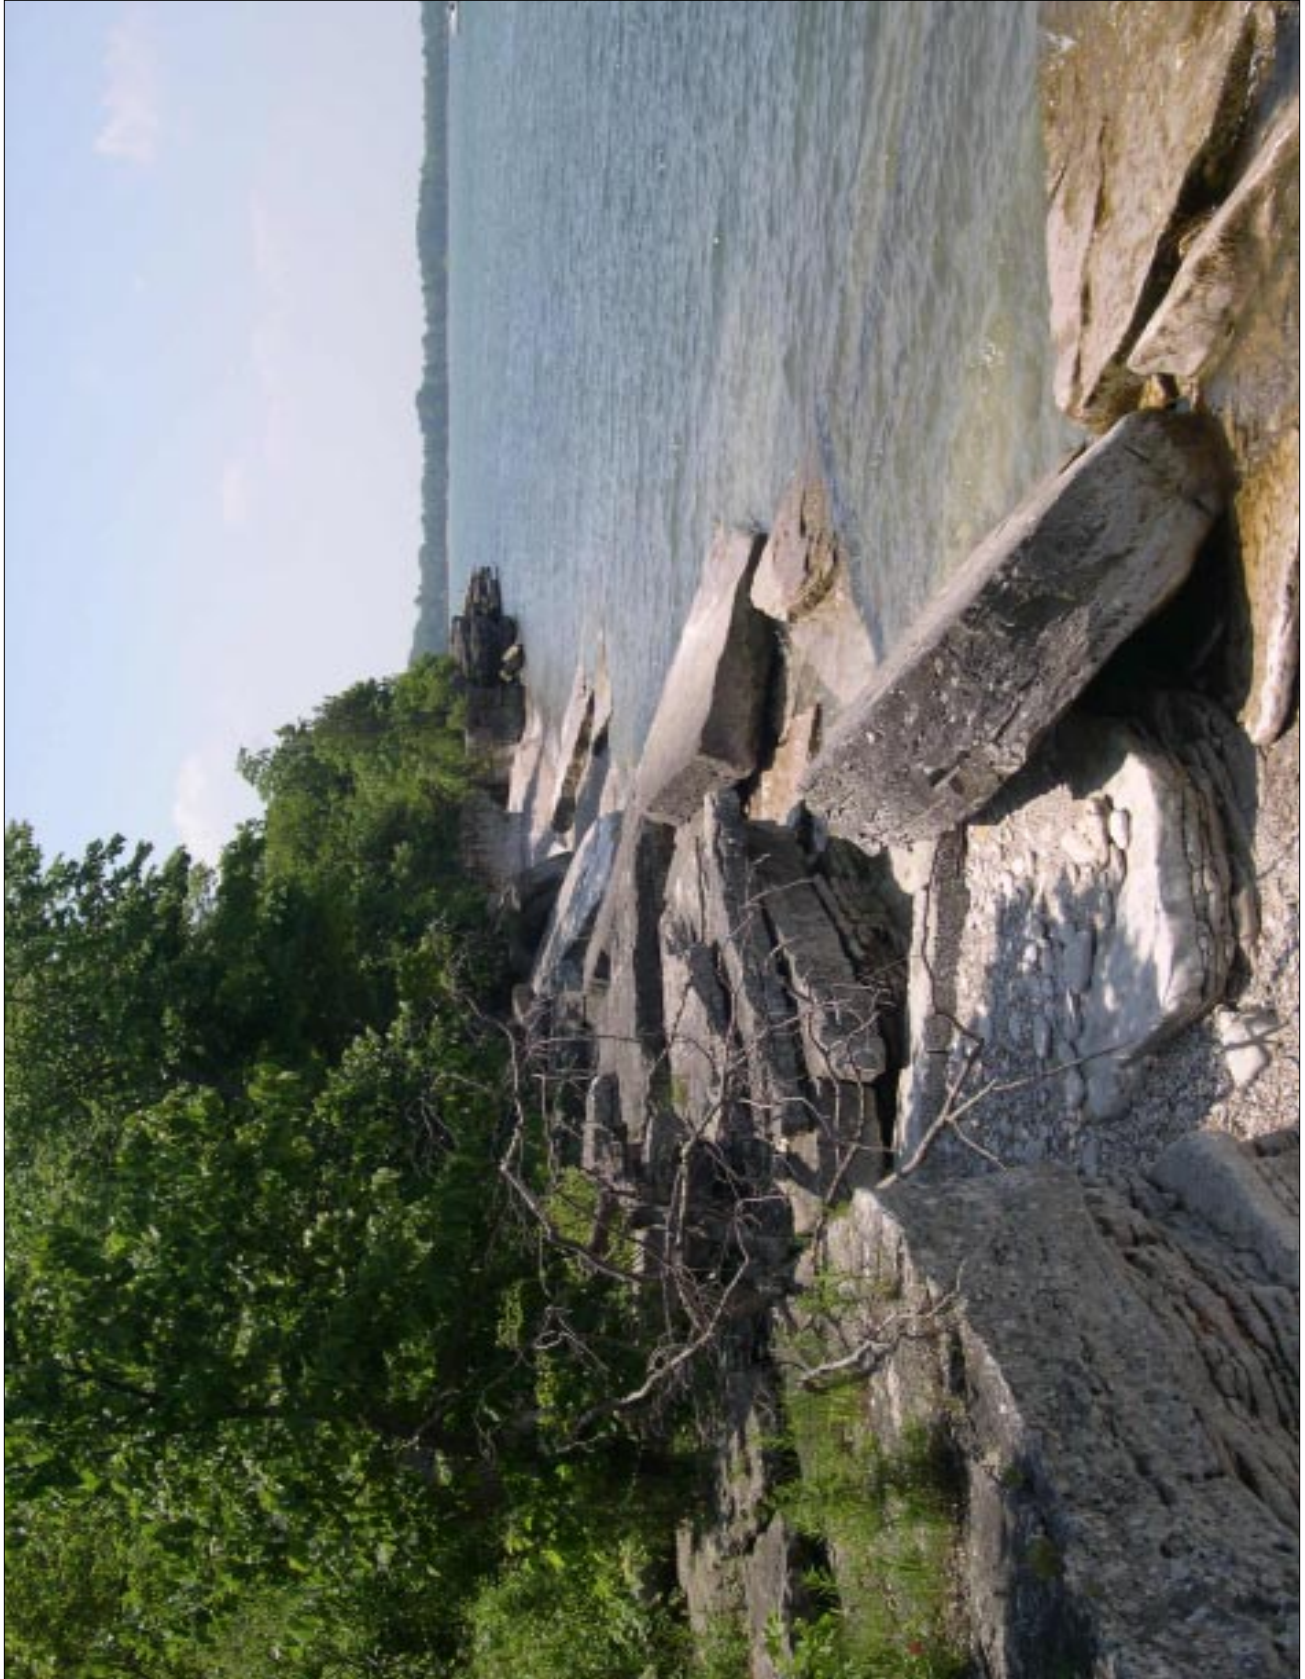
*Image SH-16. Shoreline view to the southwest at the southern edge of the Predevelopment, Ltd. tract; note bedrock ledge and dislodged limestone slabs (June 8, 2004).*
